**SUBJECT:** A helper on a steel-slitting machine died when caught in between some sheet metal and the rewind cylinder

**SUMMARY**  
**California FACE Report #05CA003**

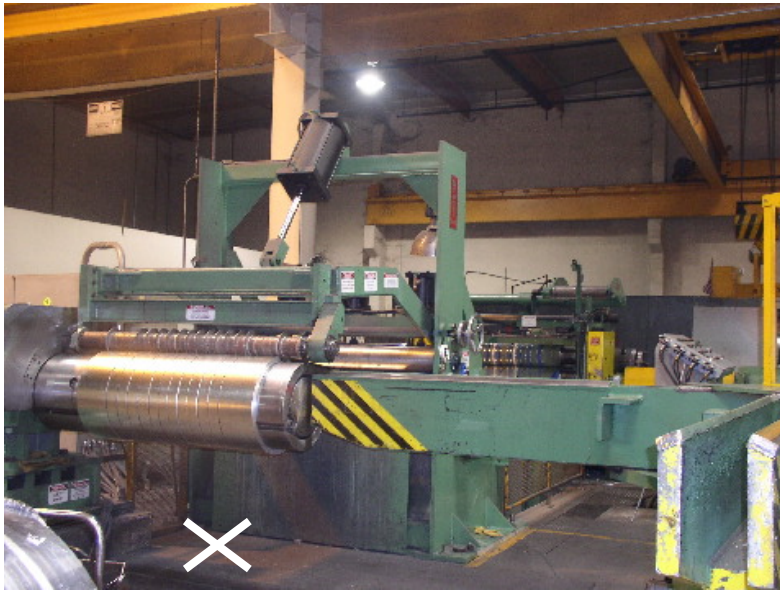
Exhibit 1: A picture of the slitter machine involved in the incident showing the cut steel being wound on the re-wind cylinder. The “X” marks the spot where the victim was caught in the steel sheet.

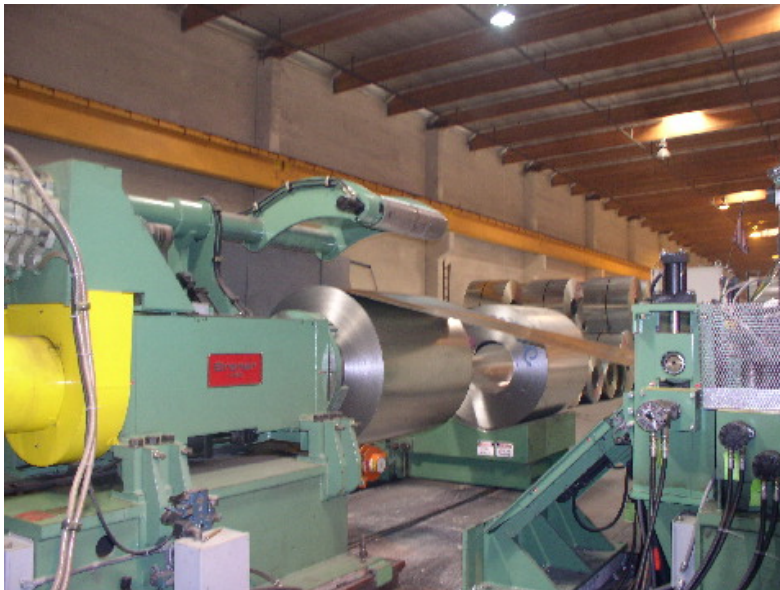
Exhibit 2: A picture of the rear of the slitter machine showing where the product is mounted on the machine, then fed into the knives for cutting.

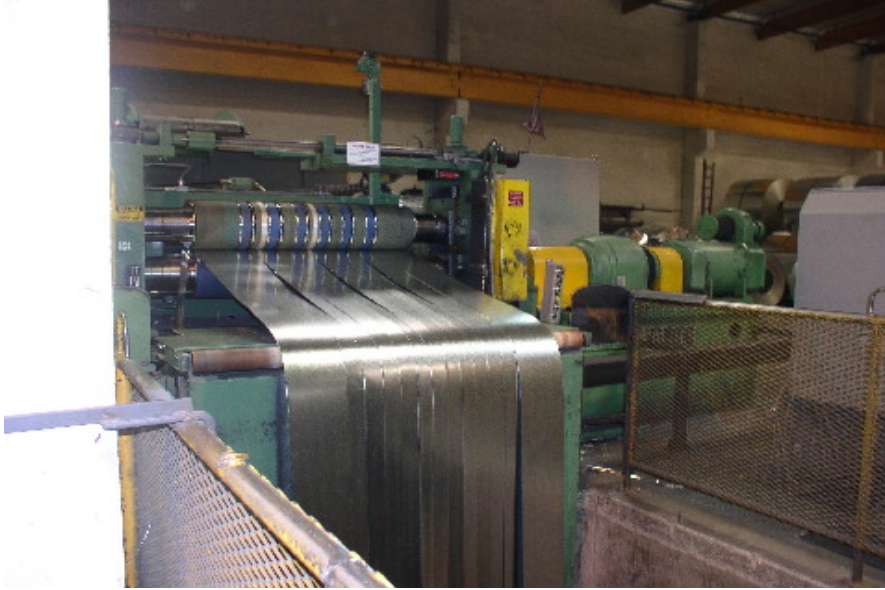
Exhibit 3: A picture of the slitter machine showing the product after it is cut into strips by the knives and then dropped into a pit to equalize the pressure on all strips.

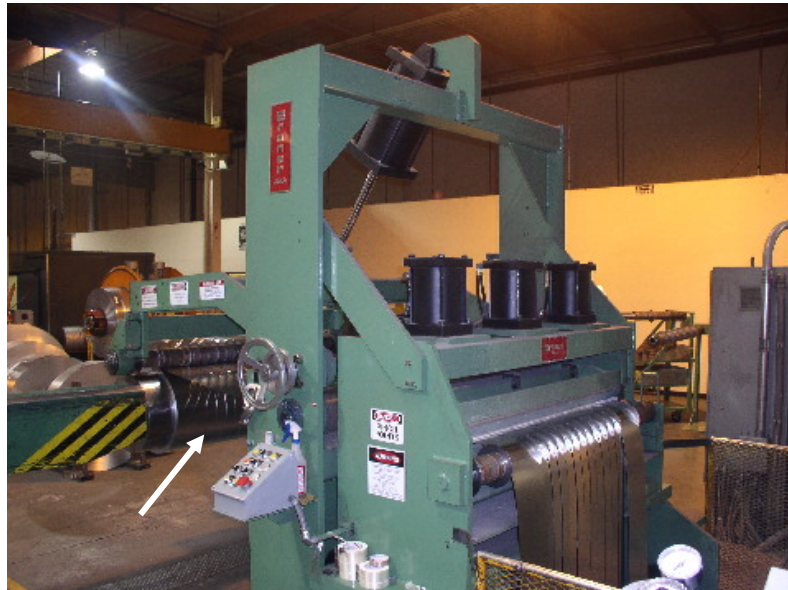
Exhibit 4: A picture of the slitter machine pulling the product out of the pit and feeding it onto the rewind cylinder. The arrow is pointing to the rewind cylinder.

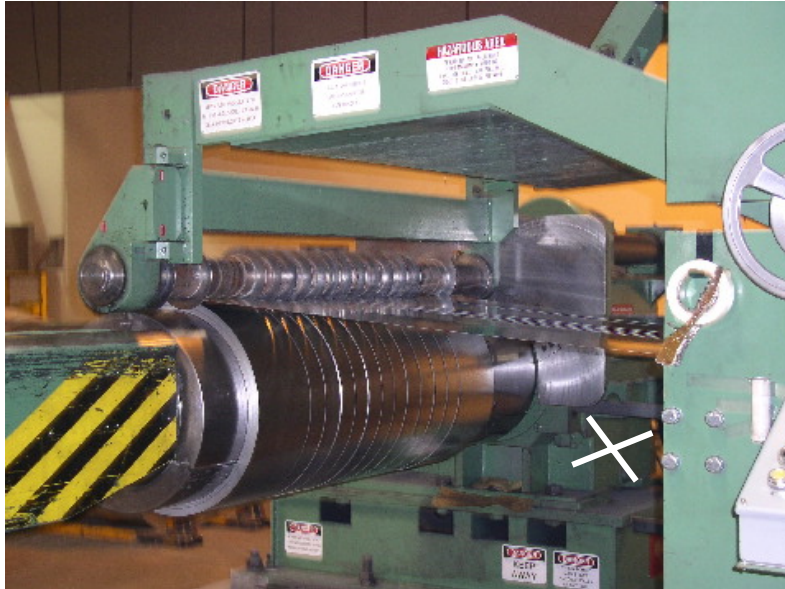
At approximately 7:45 p.m., the victim was picking up scrap pieces of material coming off the machine. This was part of his normal duties. His instructions were to pick up the scrap pieces that fell away from the machine while it was running, and not to reach into or go under the machine. Scrap formation was a normal byproduct of the process. As he was picking up the scrap, he placed himself underneath the machine where the product was being wound on the rewind cylinder. The employer said that this area was not supposed to be entered when the machine was running, but there was no guarding or barrier in place to prevent entry.

Exhibit 5: A picture of the product being wound on the rewind cylinder. The “X” marks the area where the victim entered the machine from the other side and got entangled in the cut steel sheet.

Discussion: Machines with pinch points should have guarding for the time they are running. Because of the ever-present danger of entanglement when working near moving machinery, employers should continually strive to protect employees by providing machine guarding in the areas where work is actually performed. The machine involved in this case was operating with the guarding as it had been originally set up but some moving parts remained unguarded. Employers should consider contacting machine manufacturers and retrofit, if applicable, guards that prevent workers from contacting the machine's moving parts. Proper guarding and barricades strategically placed around all moving parts can prevent accidental contact.

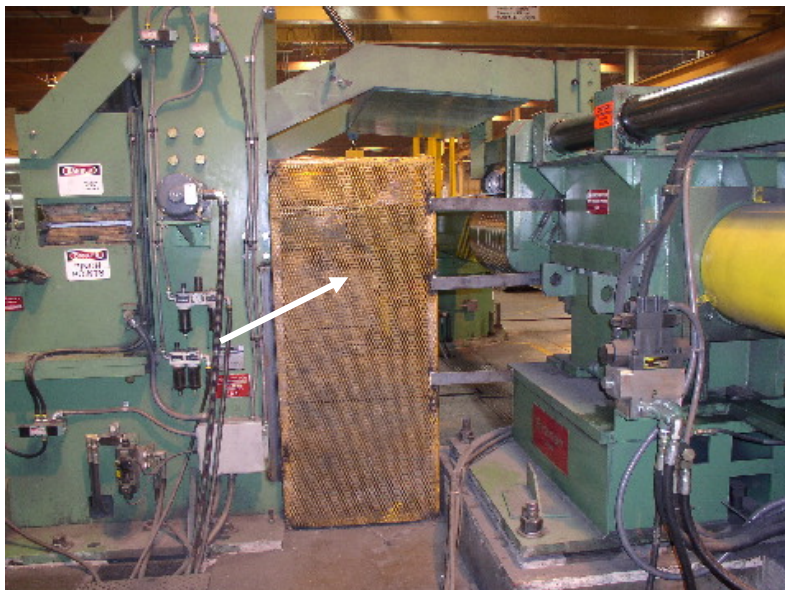
Exhibit 6: The arrow is pointing to the location where the victim went into the machine. The barricade was placed after the fatality.
